THE UNITED STATES  
STRATEGIC BOMBING SURVEY

THE ELECTRIC POWER  
INDUSTRY  
OF  
JAPAN

(Plant Reports)

Electric Power Division

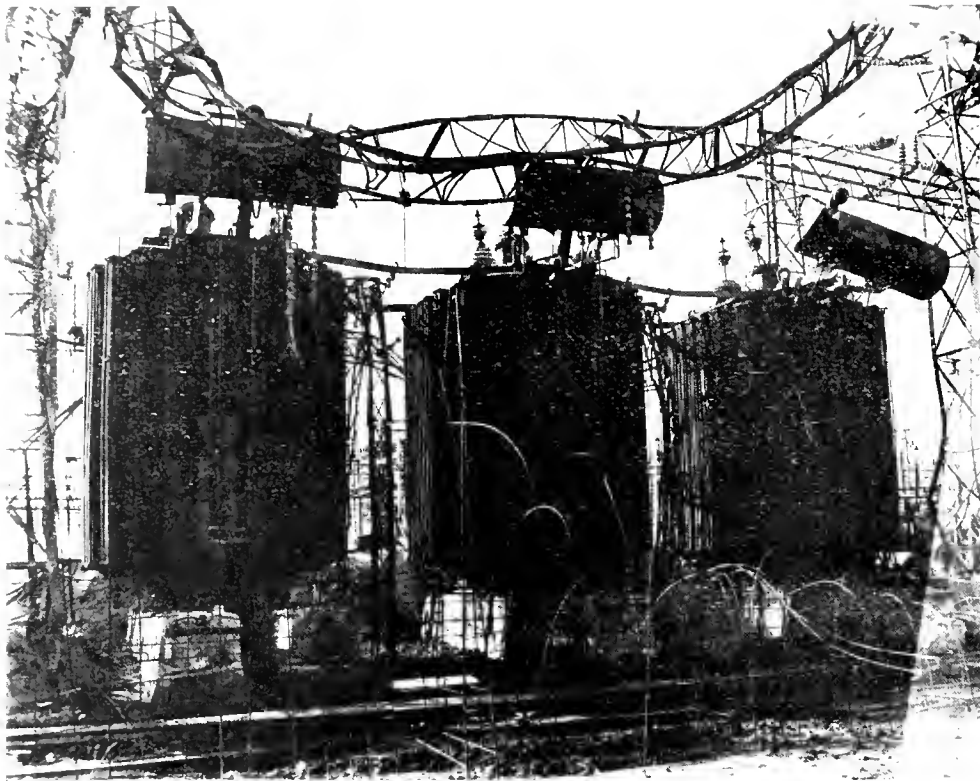
Photo 3—Another view of nearest bank shown in photo 2—reinforcing rods for protective wall in foreground

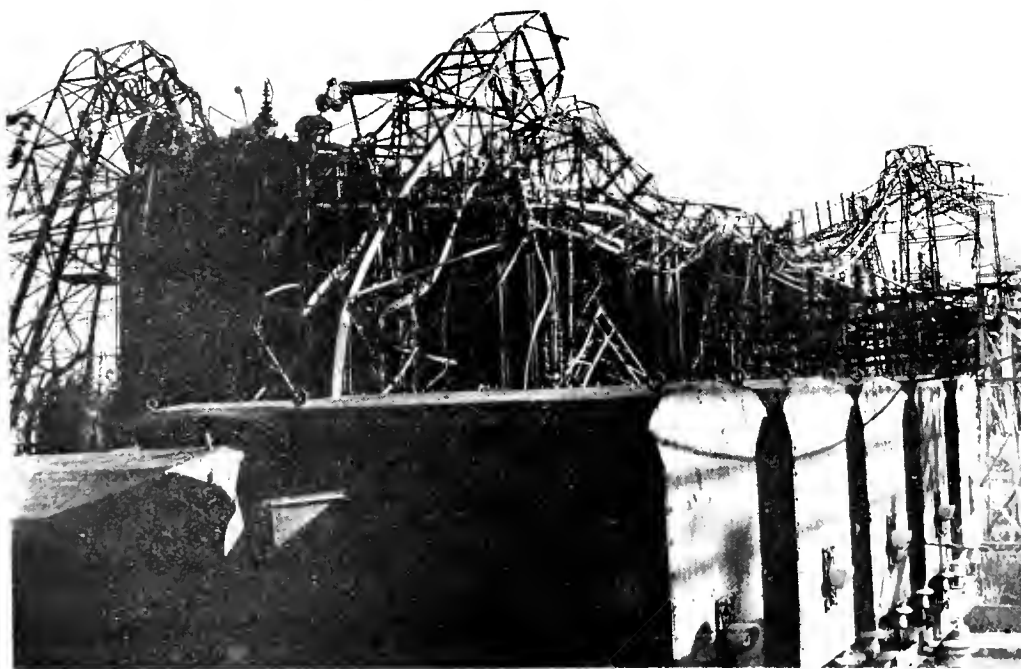
Photo 4—Another view of damaged transformers and structure, with outdoor grounding resistors in foreground

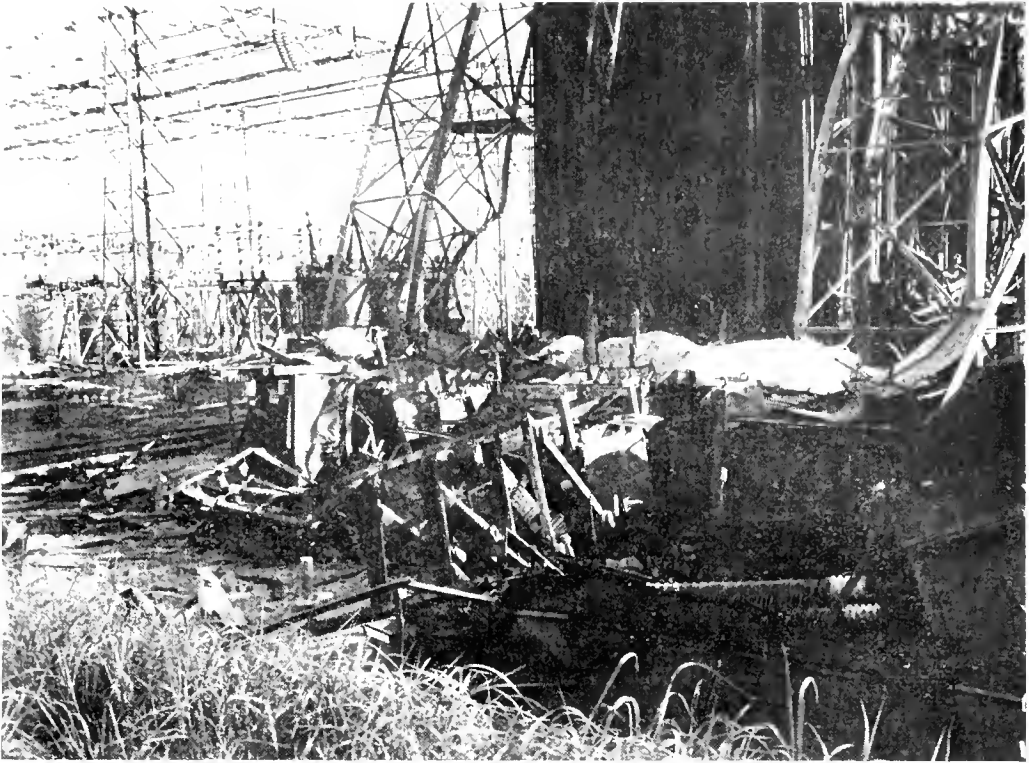
Photo 5—Closer view of damaged grounding resistors

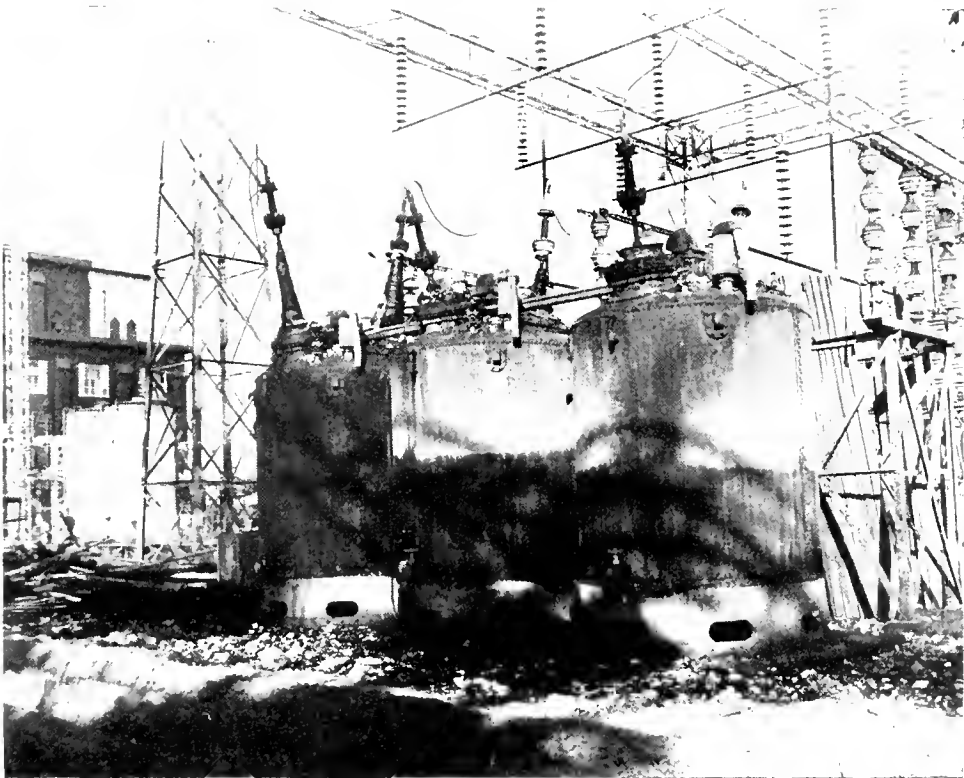
Photo 6—View showing damaged 140-KV oil circuit breaker for transformer bank No 1, with east end of synchronous condenser building at left

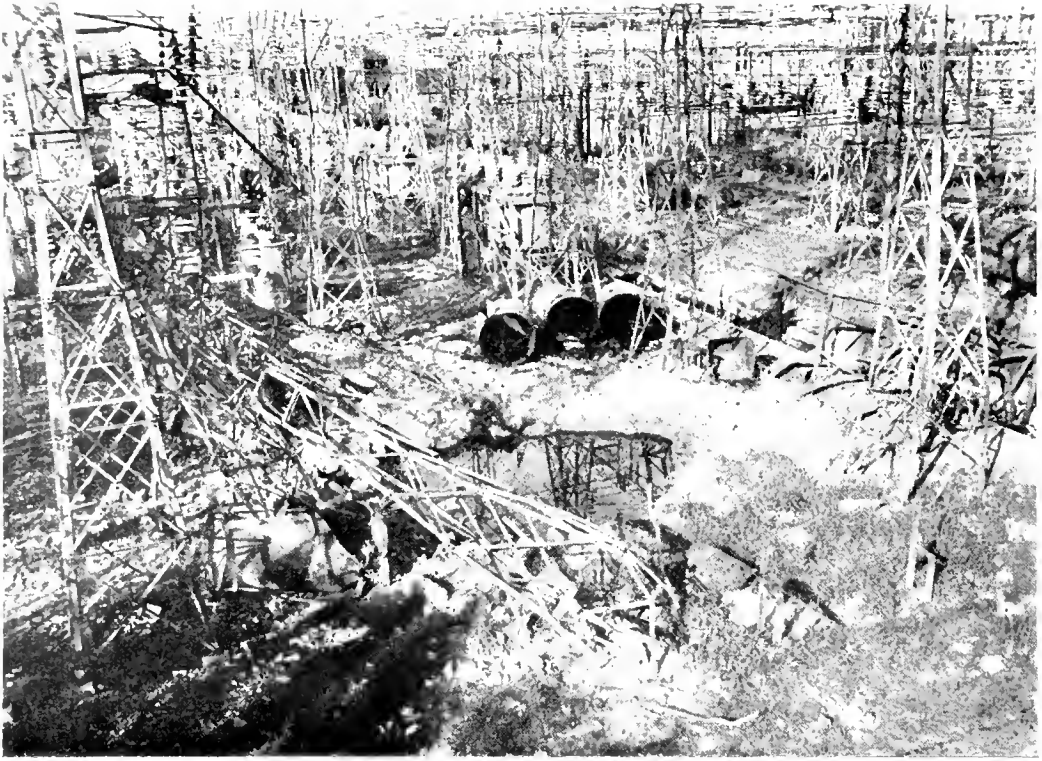
Photo 7—View showing damage done by rocket hit in 77-KV switching section

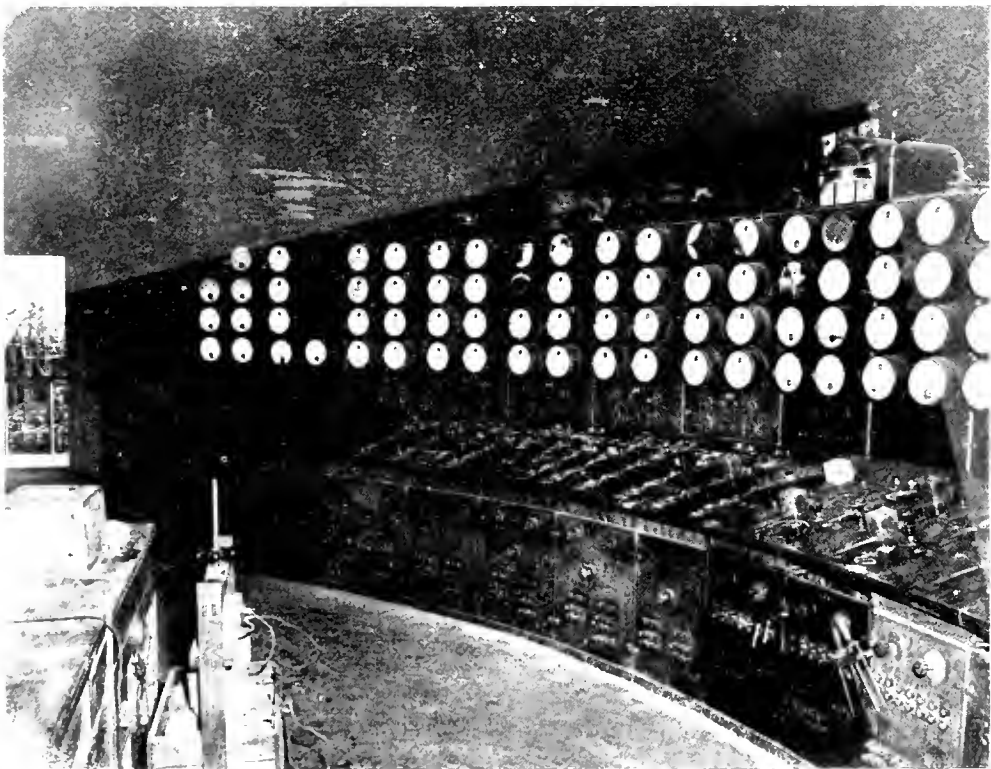
Photo 8—View of partially repaired control desk

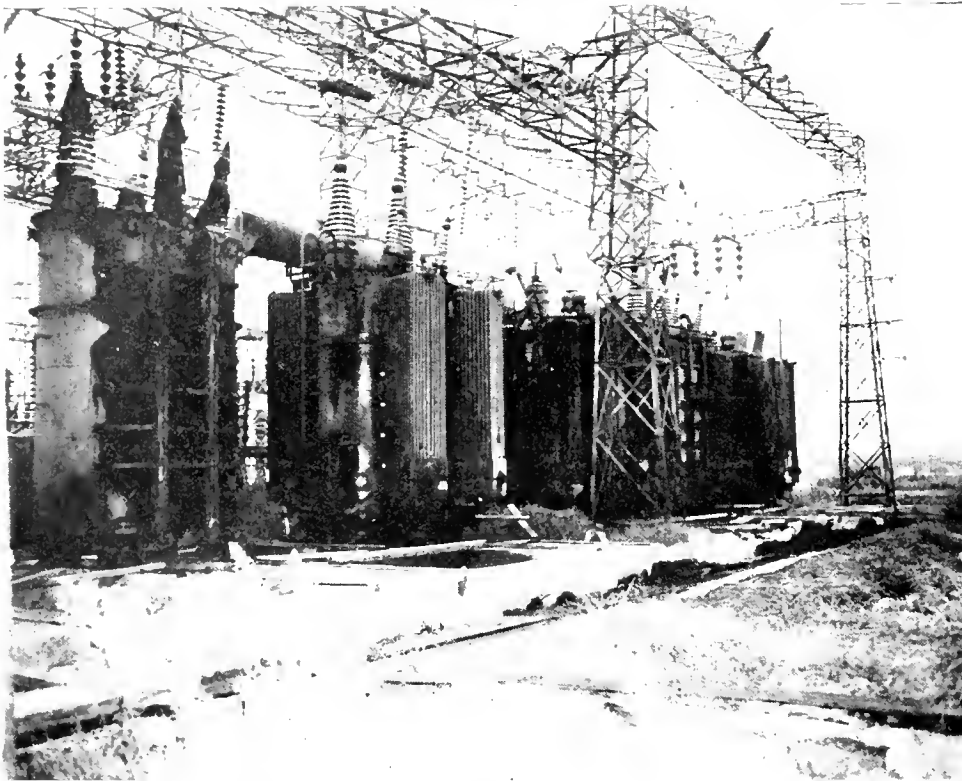
Photo 1—60,000-KVA transformer banks, showing transformer positions from left to right, numbered 2 through 6 (No 1 transformer not shown on left). Damaged transformers were originally in positions 1, 5 and 6; now occupy positions 2, 4, and 6

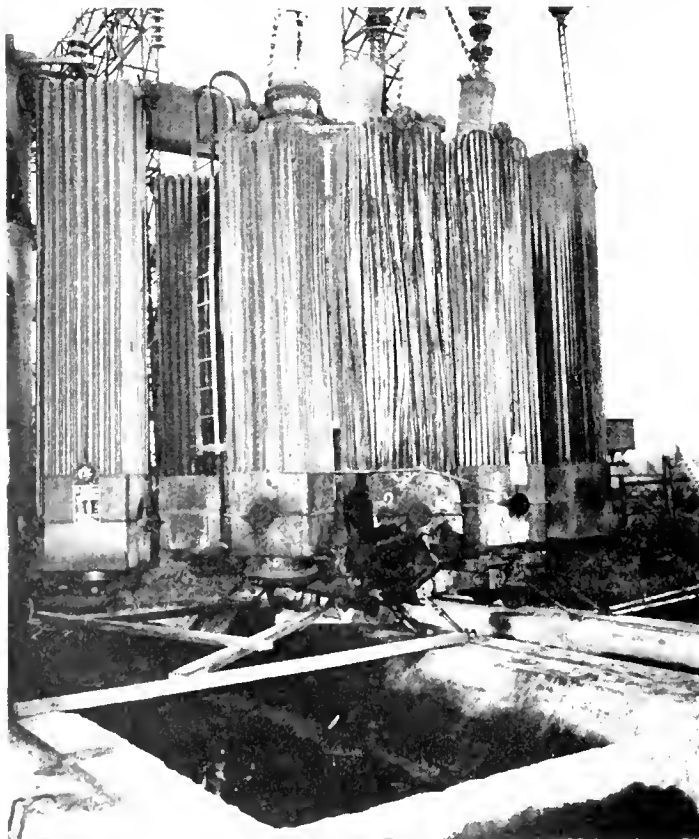
Photo 2—View showing damaged transformer in original position No 6

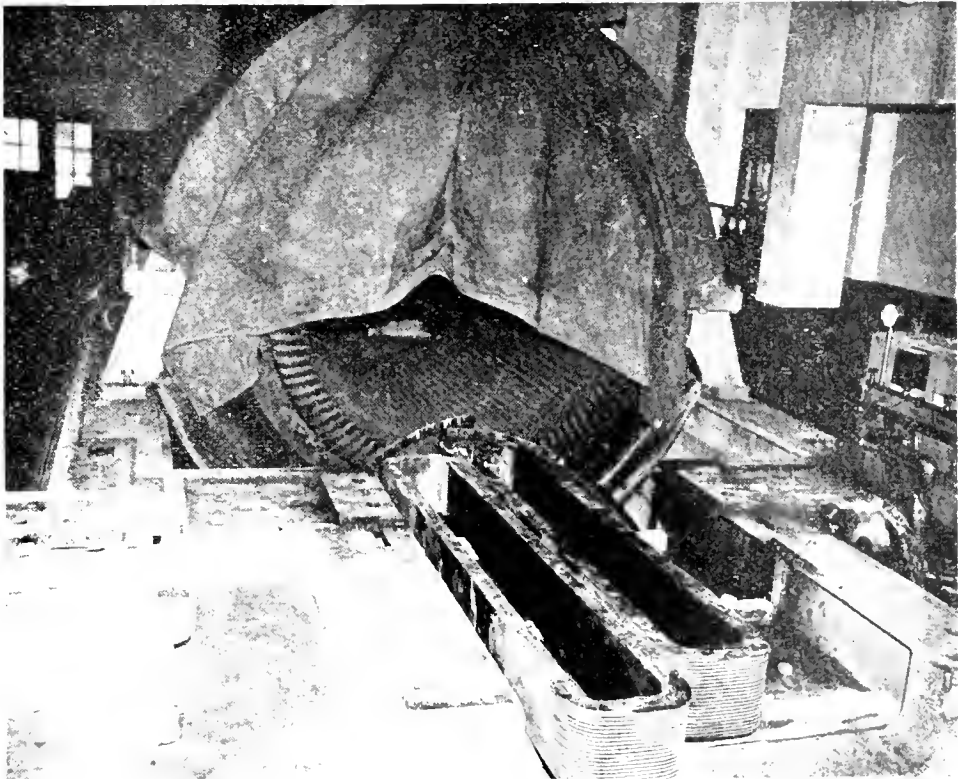
Photo 18—Hatogaya substation—30,000-KVA Mitsubishi condenser out of service because of burned out field coils (not as a result of bomb damage)

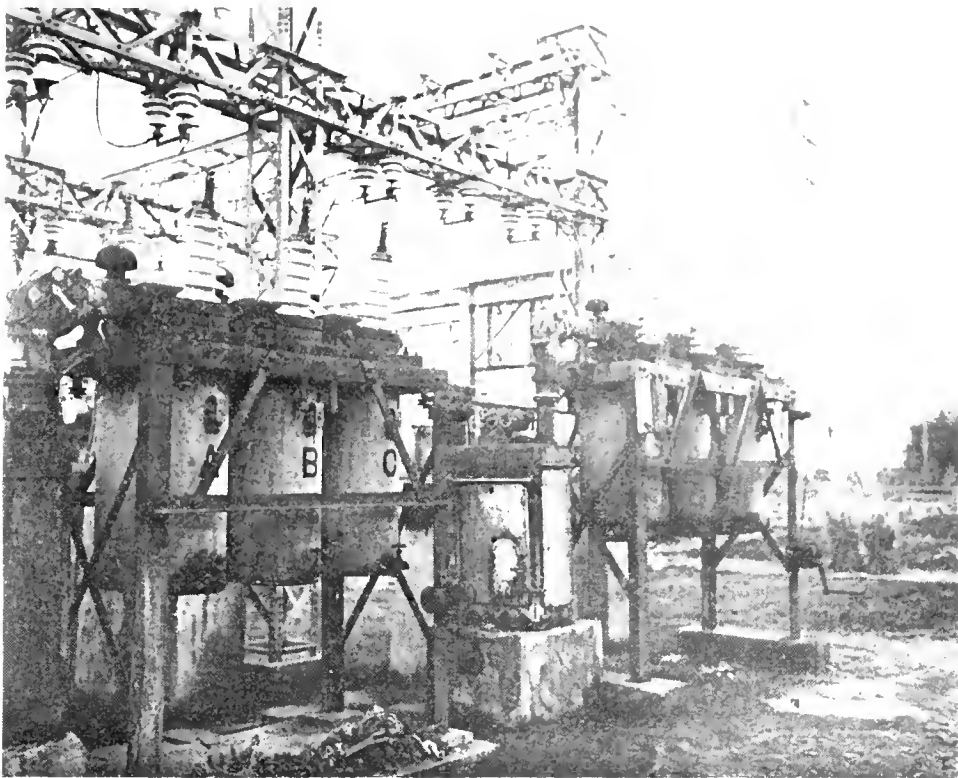
Photo 7—Chigasaki substation—22-KV OCB damaged by fire

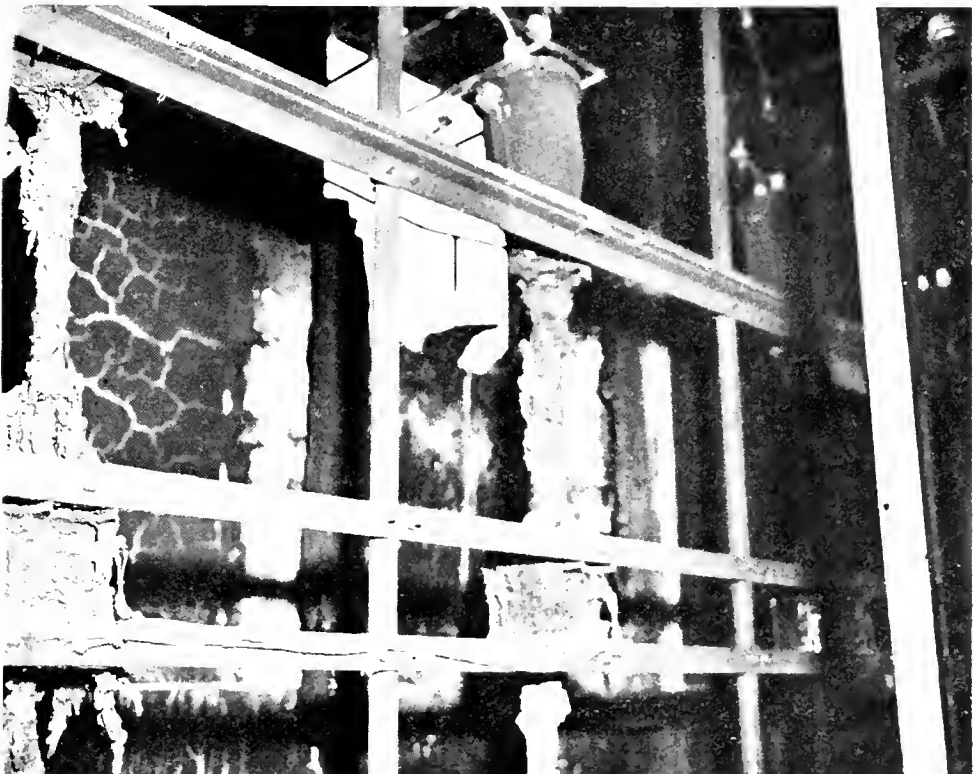
Photo 15—Kojimachi substation—Wooden blast barriers over windows burned and damaged cable entrances

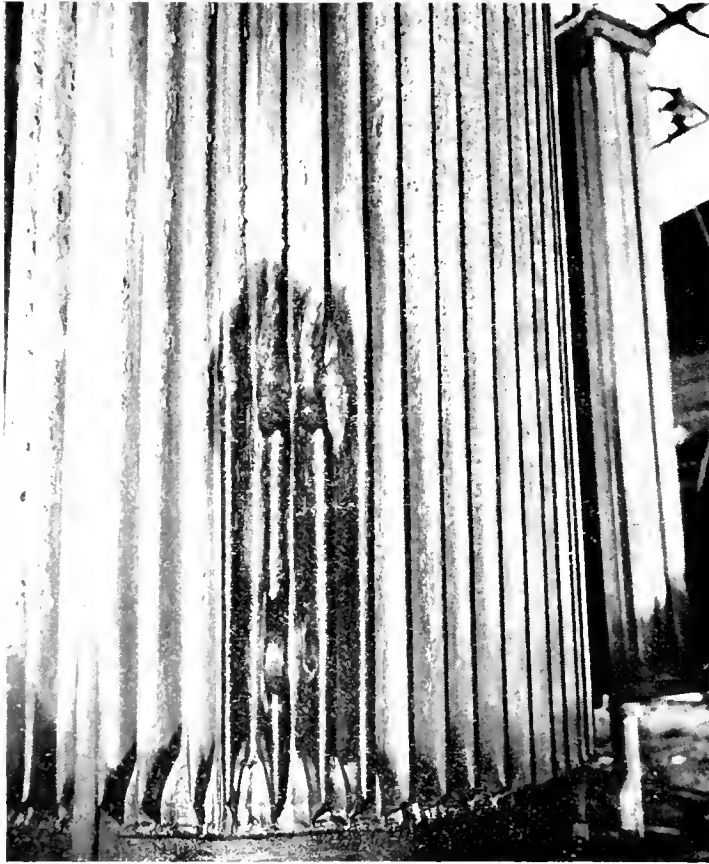
Photo 30—Ozaku substation—Example of welding repairs to transformer tank penetrated by 50-cal bullets. No fire had occurred
